AD
RDTE PROJECT NO.
USAAVSCOM PROJECT NO. 68-47
USAASTA PROJECT NO. 68-47

ARMY PRELIMINARY EVALUATION I YO-3A AIRPLANE

FINAL REPORT

AUGUST 1970

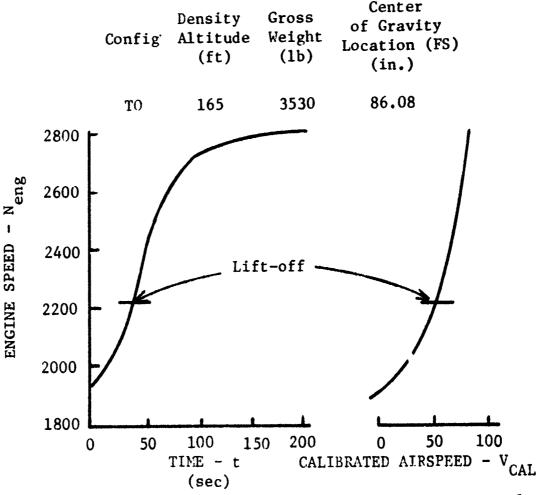
ligure A. Takeoff Characteristics. YO-3A, S/N 69-18000 Mission Equipment Installed

- A time history of engine speed and calibrated airspeed during takeoff is presented as figure A. This figure reveals the unusually long acceleration period necessary before obtaining take-off power. In order to achieve takeoff power at 2800 rpm, the airplane had to be accelerated to approximately 95 knots calibrated airspeed (KCAS). This condition occurred at 200 feet above ground level and almost 2 minutes after full throttle application and brake release. The normal procedure for airplanes with fixed-pitch propellers is to lock the brakes, apply full throttle and observe the indicated power (rpm). If takeoff power (rpm) is achieved,

the brakes are released and takeoff started. The inability of the YO-3A airplane to achieve takeoff power prior to airplane rotation is unsatisfactory. The feasibility of a constant-speed or two-speed propeller on the YO-3A airplane should be investigated. The takeoff and landing performance of the YO-3A airplane is marginally acceptable for accomplishment of the intended mission.

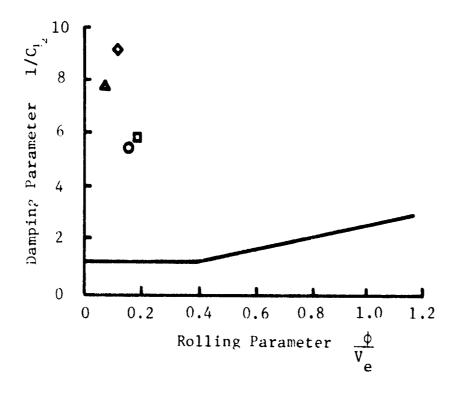
Figure C. Lateral-Directional Damping Requirements.
YO-3A, S/N 69-18000
Mission Equipment Installed

Dynamic lateral-directional stability tests were conducted under the conditions and configurations specified in appendix V. Test results are presented in figures 27 through 29, appendix II. Quantitative and qualitative results of the dynamic lateraldirectional stability characteristics were obtained by releases from steady heading sideslips, by directional control doublets and in flights during gusty atmospheric conditions. The Dutch roll response was characterized by a "snaking" motion which was moderately damped (table 12). The moderate damping of the Dutch roll oscillation is advantageous and would normally tend to reduce its derogating or nuisance influence. However, moderate rudder or lateral inputs produced large sideslip excursions which are disconcerting to the pilot and result in considerable pilot compensation required during precise and rapid heading corrections (HQRS 5). The test airplane met the lateral-directional damping requirements specified in reference 13, appendix I (fig. C).

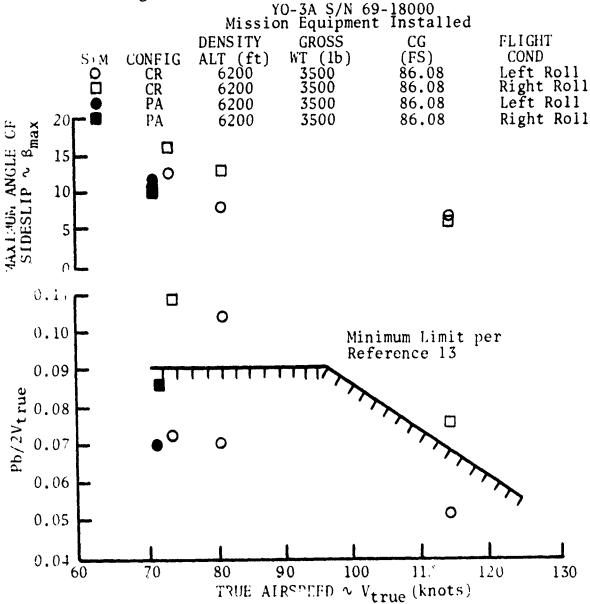
Figure F. Roll Control Effectiveness-Pedal Fixed.

S7. Roll control effectiveness tests were conducted under the conditions and configurations specified in appendix V. Test results are presented in figure F and in figure 33, appendix II. All roll control effectiveness data presented herein are derived from full (or maximum available) lateral control deflections unless otherwise specified. In the power approach configuration, the time required to achieve a 30-degree angle-of-bank change (ϕ_t = 30 degrees) was 1.5 second for right rolls and 2.0 seconds for left rolls. The corresponding roll performance requirement, in terms of the wing tip helix angle parameter (pb/2V) was 0.087 radians to the right and 0.07 radians to the left. The large amount of pedal force required to negate the adverse sideslip generated during rolling maneuvers from lateral stick-only inputs resulted in an initial roll

response in the proper direction. As the adverse sideslip began to increase the yaw rate decreased toward zero. Then, as the adverse sideslip effect decreased, the yaw rate began to increase. The combination of low effective dihedral (${}^{C}\ell_{\beta}$) and a large, adverse sideslip characteristic is disconcerting to the pilot. This combination is especially noticeable during night (instrument) operations where the turn entry is characterized by a decrease in yaw rate immediately following stick input. Rolls to the right exhibited better performance than rolls to the left. This characteristic was attributed to the left lateral stick contacting the pilot's leg. The time required to achieve a 60-degree bank angle change (ϕ_t = 60 degrees) during flight at 73 KTAS was 3.0 seconds. This characteristic is indicative of mediocre roll performance and results in considerable pilot compensation to achieve adequate performance (HQRS 5).

- Roll control effectiveness with respect to the wing tip helix angle parameter (pb/2V) is presented in figure F. Rolls to the right in the cruise configuration met the requirements of reference 13, appendix I. As stated previously, the restriction of left-lateral stick displacement is the primary cause of the derogation of left rolling performance. The roll control effectiveness characteristics of the test airplane result in considerable pilot compensation to obtain adequate performance for the intended mission (HQRS 5).

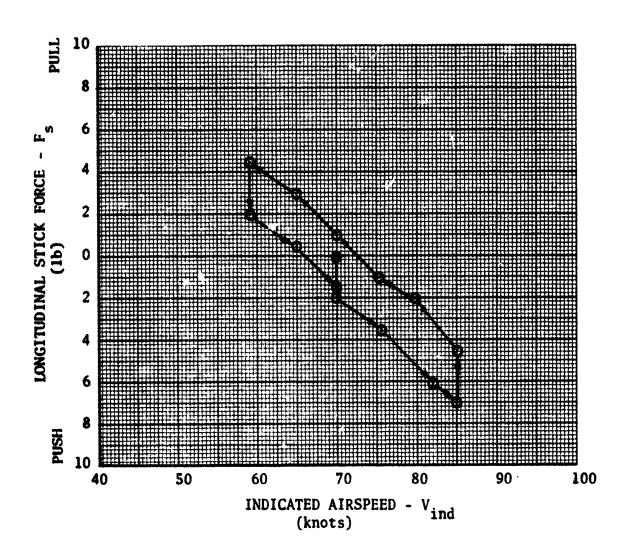
FIGURE 34

- 80. The test airplane's control system exhibited three-quarters of a pound breakout force with a total breakout plus friction force of 2½ pounds (fig 34, app II). Although the breakout plus friction force characteristic is within the limits of reference 13, appendix I, it is, nevertheless, excessive for the satisfactory accomplishment of the intended mission. The large breakout plus friction band complicates and masks the stick force versus airspeed gradient and results in minimal pilot cues. The combined effect of a large breakout plus friction band and divergent phugoid results in an extensive pilot workload in order to achieve adequate performance (HQRS 6). The longitudinal breakout plus friction force is a deficiency and correction is mandatory for the satisfactory accomplishment of the intended mission.

LONGITUDINAL CONTROL FORCE CHARACTERISTICS YO-3A S/N 69-18000 MISSION EQUIPMENT NOT INSTALLED

Breakout plus friction = 2 lb.
 Friction band = 2½ lb.
